## Supplemental Rear Turn Signal Modification Instructions for 2018 and Newer CRF1000L & Adventure Sports

01-402-6555/6556-0 Kofferträger Edelstahl Honda CRF 1000L Africa Twin ab 2018

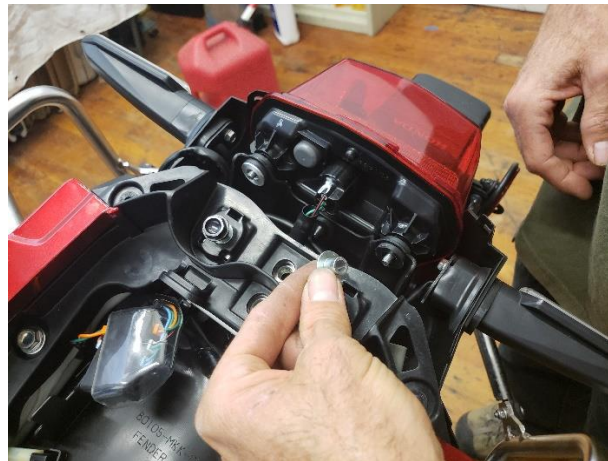
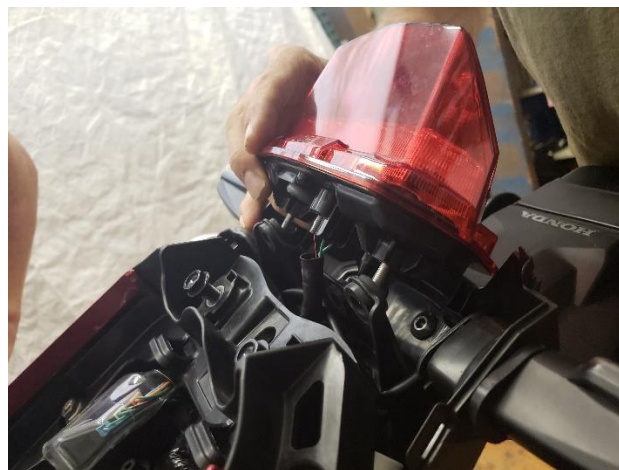
- Remove the front and rear seats
- Remove the factory top rack
- Remove the black plastic panel above the tail light
- Remove the two nuts holding the tail light in place, remove the metal inserts, and tilt the tail light upward, releasing it from the bottom grommets. Move the tail light out of the way to access the turn signal mounting bolts.

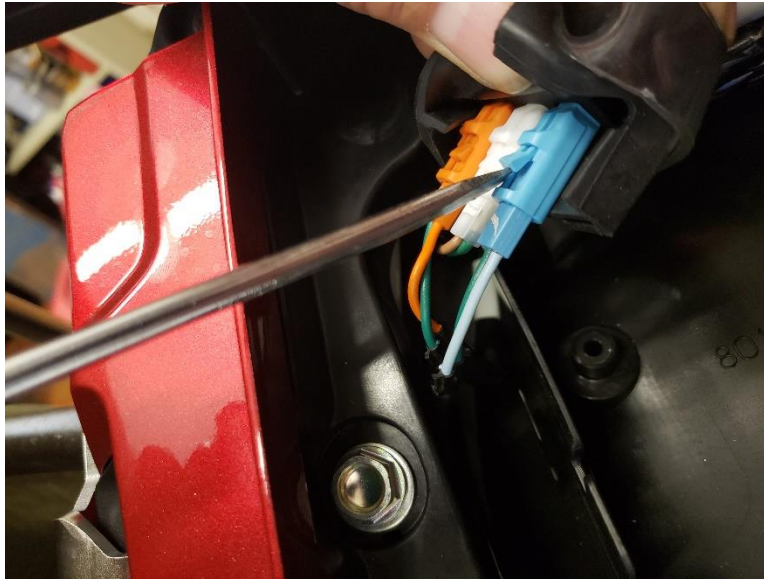
- Disconnect the tail light wiring (orange and blue plugs).

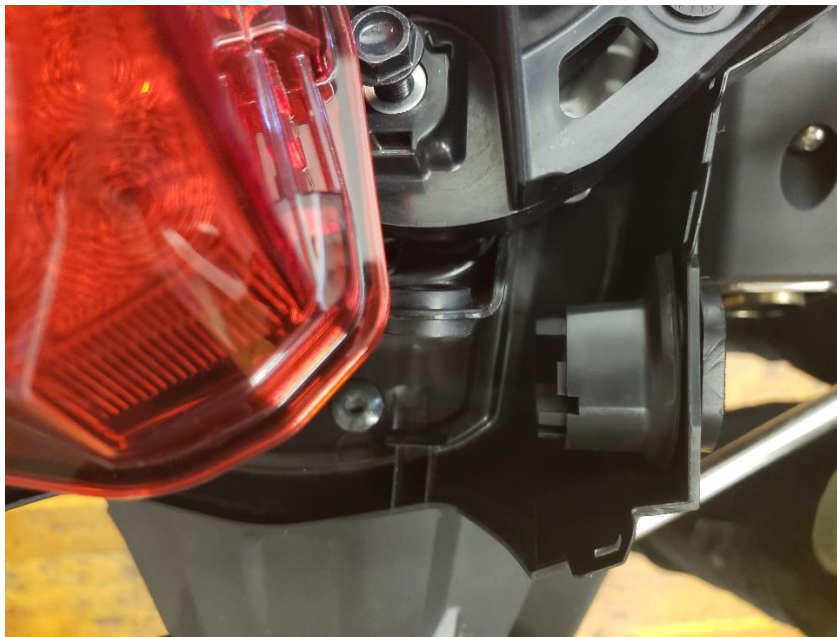
- Remove nut securing turn signal, then remove turn signal from bike, being careful while pulling wiring through the tail section of the bike.
- Remove metal insert from rubber spacer/grommet on turn signal, now the rubber grommet can be removed. Pull wiring through rubber grommet.
- Now reinstall turn signal with rubber grommet and metal insert on the *inside* of the tail section. Re-route the wiring and connect it to the color matched connectors.

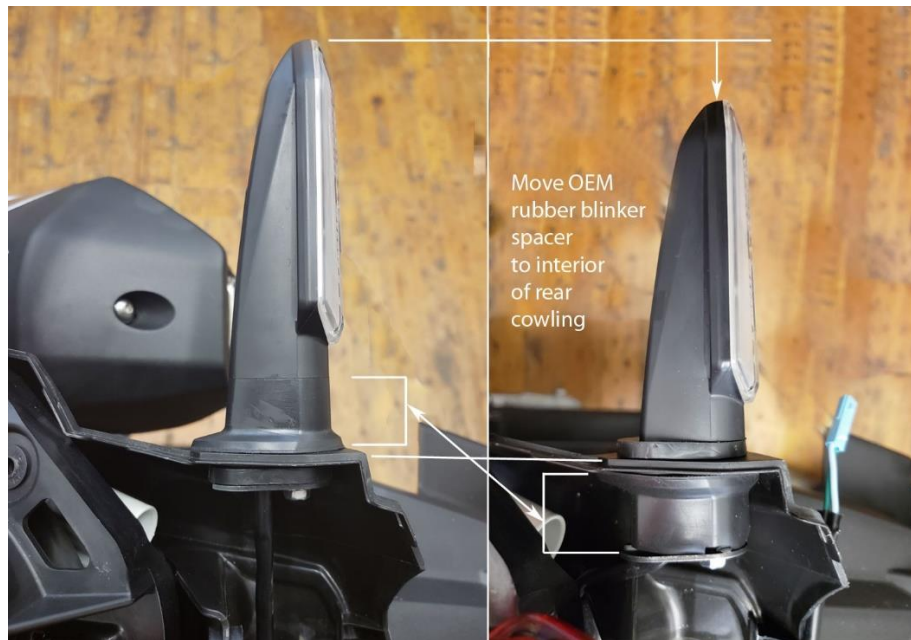
- Your turn signal should now look like the image on the right:

- For the most uniform look perform this modification on both rear turn signals.
- Re-assembly for tail of motorcycle and rear rack is reverse of disassembly.
